Oval pens driving you nuts?

Join the crowd. If your lathe—or your turning work—suffers from poor alignment, call a time-out and review these five alignment checkpoints.

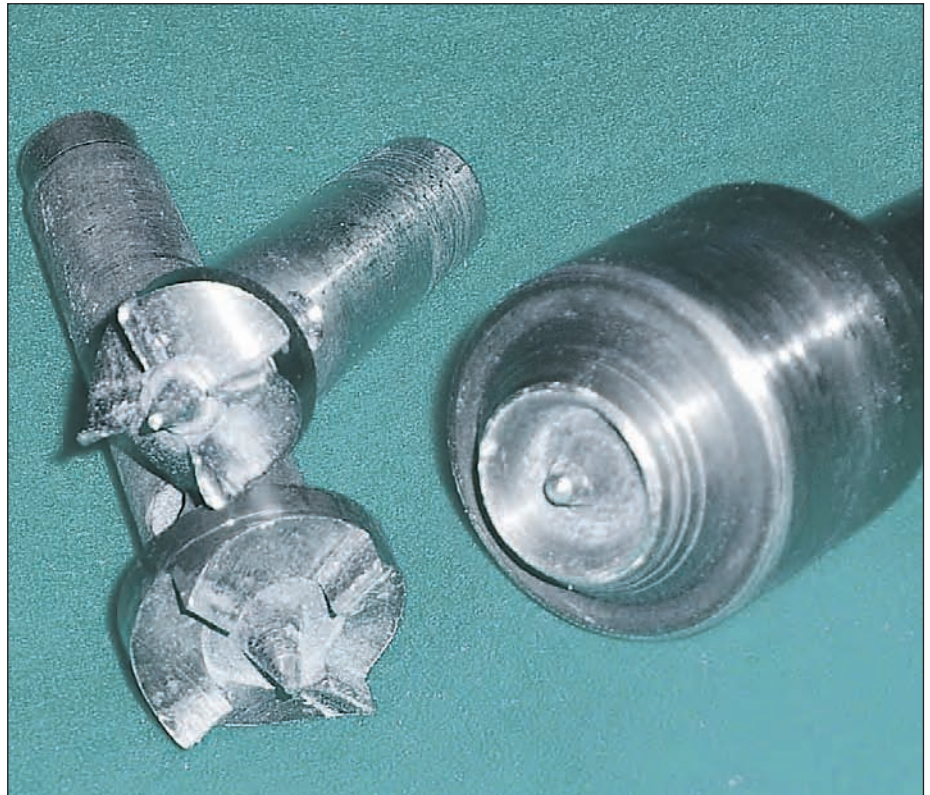
Inexpensive live centers, centers with worn out bearings, or poorly designed live centers like the examples at *right* cause problems. If the live center was inexpensive, just discard it and upgrade.

One of the causes of a live center becoming out of true is excessive wear of the bearings due to operating the lathe with a headstock/tailstock misalignment. Angular pressure on the live center will rapidly increase the radial runout to an unacceptable point. (Oneway advertises that the radial runout of its live center system is less than .001 inches.)

If you have a reliable live center that's repairable, consider replacing the bearings. For a minimal fee, you can return many live centers for bearing replacement.

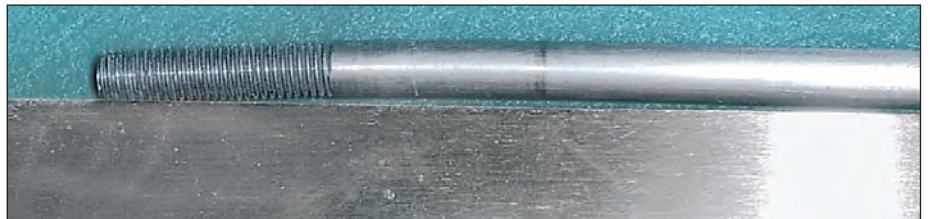
If your pen barrels are oval and you've checked the first two solutions, applying too much pressure to the tailstock when tightening on the mandrel may be the culprit. The amount of pressure applied should be just enough to stabilize the mandrel shaft and minimize vibration from the turning activity. Too much pressure bends the shaft (*middle right*).

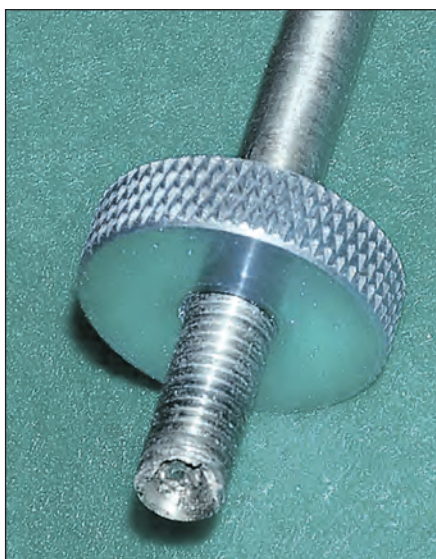
A crooked live center point will also cause the mandrel to operate eccentrically and will enlarge and distort the alignment dimple in the tailstock end of the mandrel shaft (*bottom right*). The better designed mandrels allow the user to replace the shaft when it becomes bent or the dimple has excessive wear.

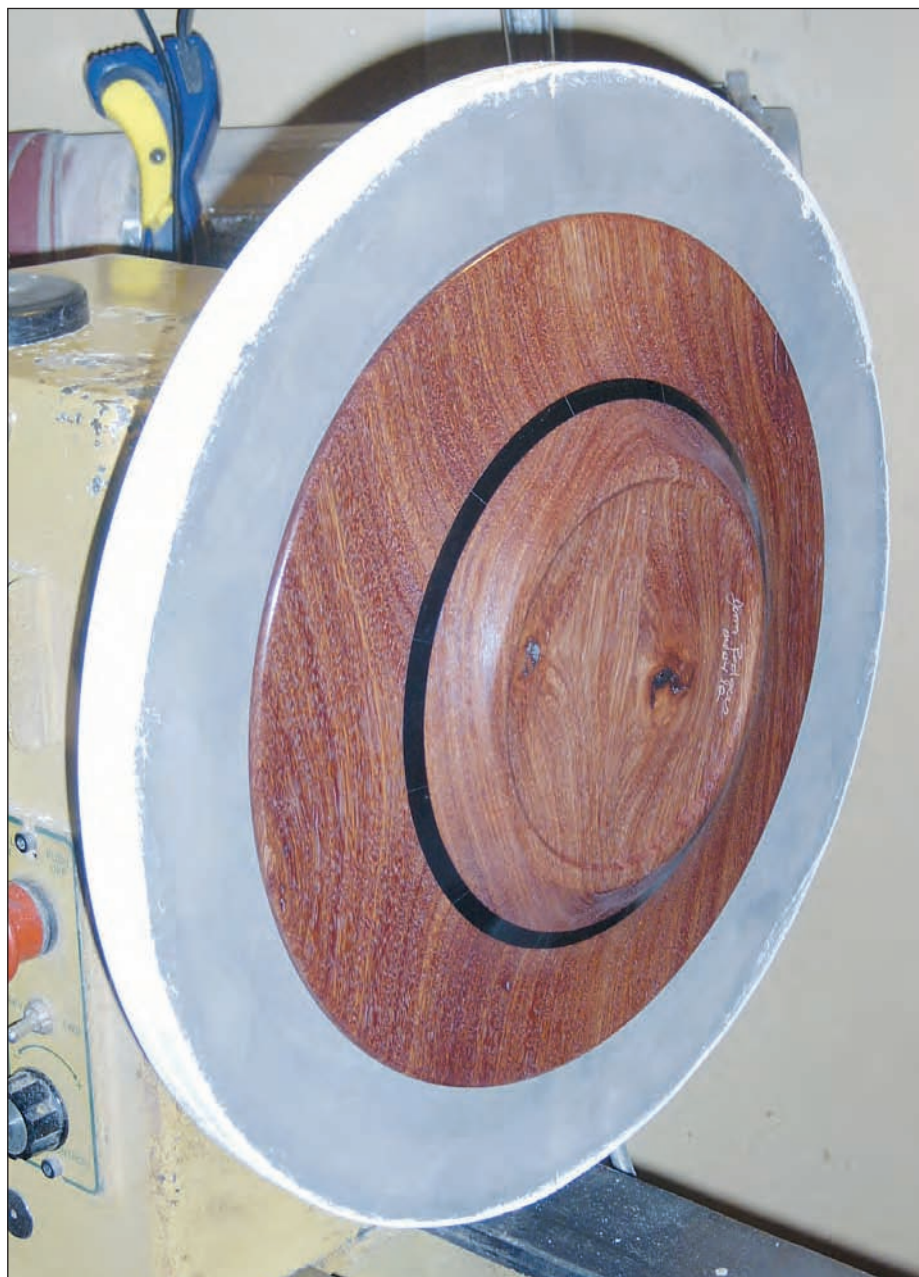
On a finished edge bowl, consider using a flat plate as a vacuum chuck, thus spreading out the hold over a large area and minimizing the problem as shown at *left*.
